# 5 Ecological Restoration

# Coastal dune restoration at Point Reyes pays off for three federally listed species

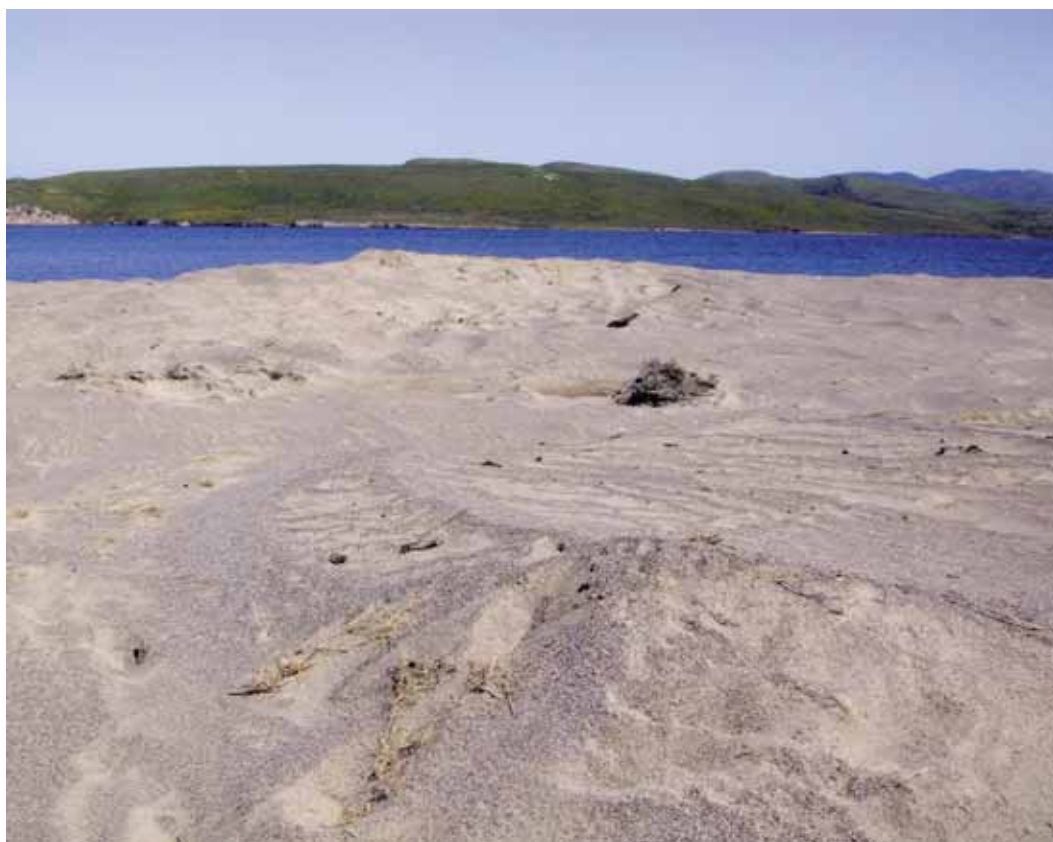
Urbanization and nonnative plants have reduced coastal dune habitats to 10% to 40% of their original distribution along the west coast of the United States. As of FY 2005, Point Reyes National Seashore has cleared approximately 45 acres (18 ha) of dunes of European beachgrass and other nonnative plants to restore natural processes and improve habitat for federally listed species.

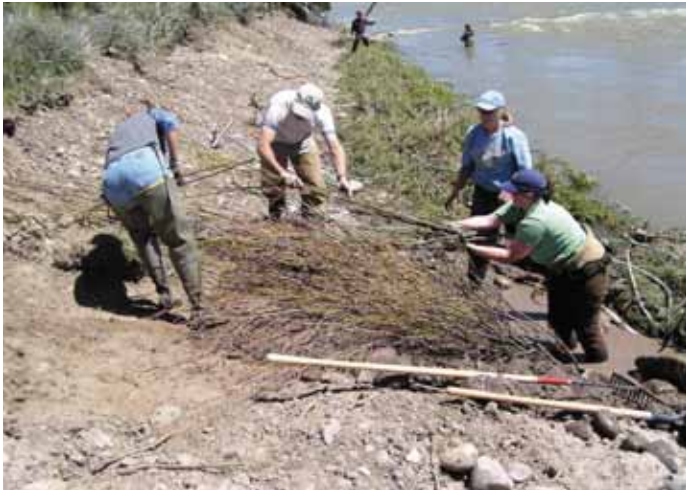
To stabilize the west bank of the Snake River, Grand Teton National Park cooperated with numerous organizations and agencies: the Teton County Conservation District; the Teton Science School; the Natural Resource Conservation Service (NRCS) National Design Construction and Soil Mechanics Center in Fort Worth, Texas; the NRCS Plant Materials Center in Aberdeen, Idaho; the NRCS in Casper, Wyoming; Rendezvous Engineering (a local engineering firm); Grand Teton Lodge Company (a park concessionaire); Jackson Hole One-Fly; and the National Fish and Wildlife Foundation. Here, workshop participants are installing a brush mattress from live willow stakes to protect the streambank from erosion.

IN 2005, GRAND TETON NATIONAL PARK coordinated a successful collaborative effort to stabilize a section of the Snake River near its park headquarters in Moose, Wyoming, using state-of-the-art bioengineering techniques. In response to 1997 flood conditions, the west bank of the river eroded as much as 5 feet (1.5 m), which caused concern for park facilities. This area is highly visible to park visitors and offered a great opportunity to design an informative demonstration project, illustrating the use of innovative restoration and stabilization techniques in lieu of the typical bank armoring. The techniques used to restore area riparian vegetation and fish habitat included a combination of brush and rock barbs, vertical willow bundles, brush revetments (retaining walls made of brush), pole plantings, and brush mattresses. In a park setting, these techniques are much more appropriate (not to mention more aesthetically pleasing) than armoring the banks with large boulders, as had been done in the past.

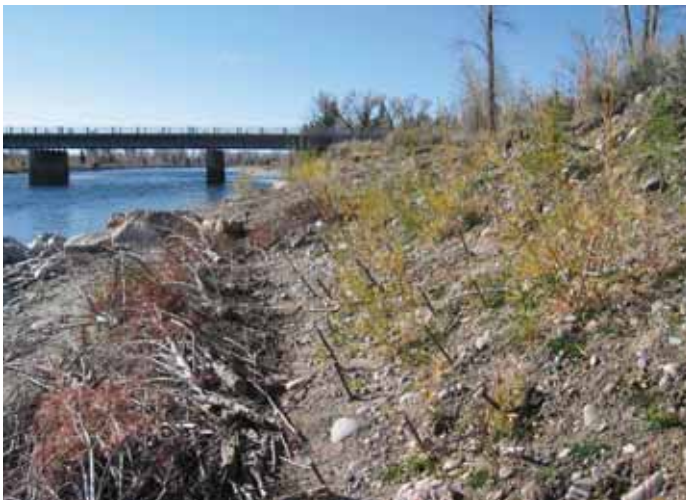
Success! Sediment deposition along the brush revetment (left) and willow growth from pole plantings and vertical bundles (right) offer a more gentle slope along the west bank of the Snake River at Moose, Wyoming, after the stabilization and restoration project.

Results have been spectacular. Plantings experienced a 95% success rate and sediment deposition is rapidly occurring along the riverbank. Streambank vegetation, bank stability, fish habitat, and aesthetics have all been improved along this reach of the Snake River. This project is an outstanding example of how innovative streambank bioengineering techniques could be used in similar situations throughout the National Park System. ■

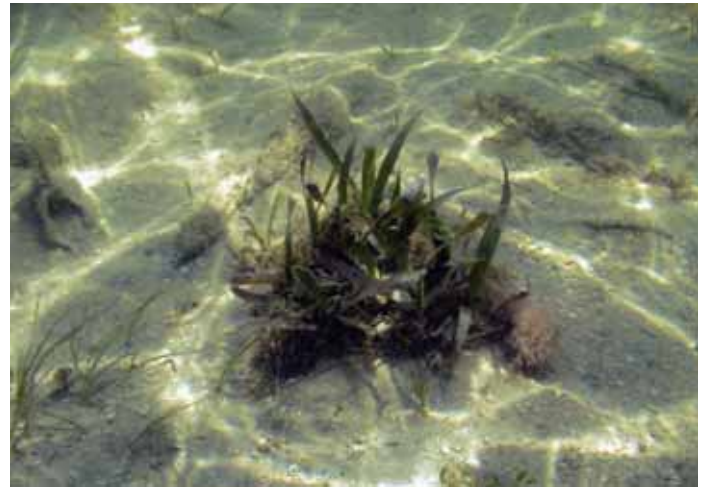
Seagrass restoration at Biscayne National Park involved placement of sediment-filled burlap bags in trenches where powerboats had run aground and their operators had attempted to free themselves from shallow water. The Tom’s Tug site is the largest of three restoration areas and is shown immediately after placement of the bags in June 2004.

By May 2005 a transplanted seagrass plug had begun to recruit new growth at the restoration site.

The *Pure Pleasure* site consisted of two propeller scars. The restoration team backfilled the site with approximately 1 cubic yard (0.8 cu m) of sediment, which was batch-mixed by a concrete mixer and shoveled into 45 burlap bags. The sediment included fine silica sand, diatomaceous earth, calcium carbonate sand, and an organic material added at 5% by weight. After placing the bags into the trenched areas, the team slit them to allow water to flow freely around them and distribute the sediment. In June 2005 the

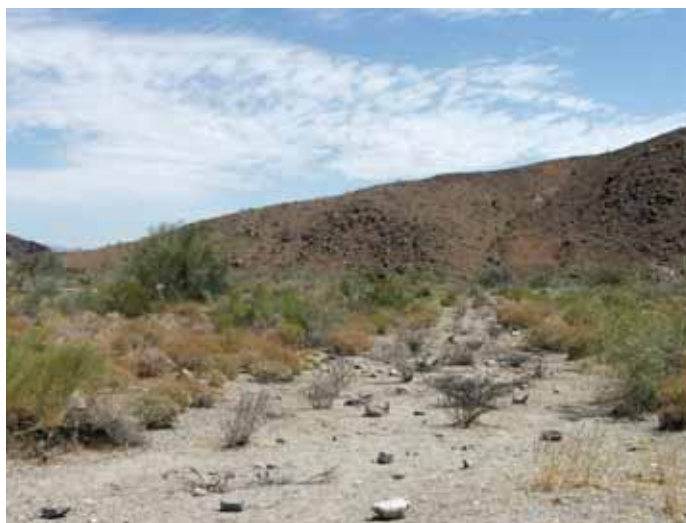
Old roads at Joshua Tree National Park are being rehabilitated to disguise or clearly mark them as closed so they will not be mistaken as legitimate driving routes. Park staff has applied a technique of “vertical mulching,” or planting dead vegetation and spreading rocks, so that barren areas will blend into their desert surroundings and begin the process of natural revegetation. Boulders and “no motor vehicles” signposts are also employed as needed.

The most effective technique for disguising closed roads at Joshua Tree National Park is vertical mulching. This process involves planting dead vegetation (taken from nearby areas) to simulate living shrubs. In addition to blocking access, the technique encourages natural regrowth by providing shelter from sunlight and protection from wind for seeds and seedlings. Other road-closing techniques are installation of posts or fencing, strategic placement of boulders, planting seeds, transplanting existing plants, recontouring the road surface, and scattering rocks along it.

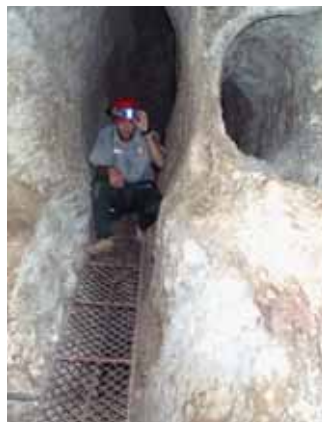
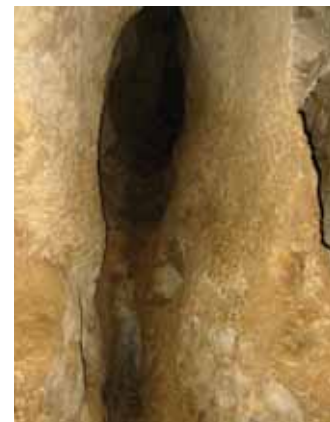
Walkway area before and after restoration.

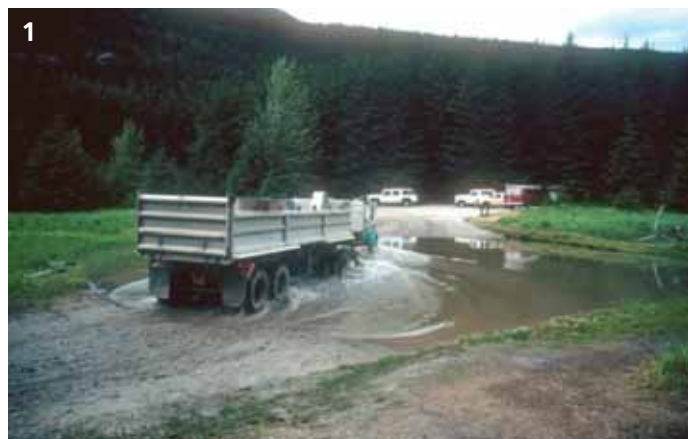
Years of unrestricted traffic had significantly impacted a 1-acre (0.4 ha) wetland area known as Nelson Slough at Klondike Gold Rush National Historical Park. Protection of the slough was identified as a priority in the late 1990s after the Alaska Department of Fish and Game documented the presence of salmonids in Nelson Creek and the importance of the slough's wetland complex as habitat for juvenile coho salmon.

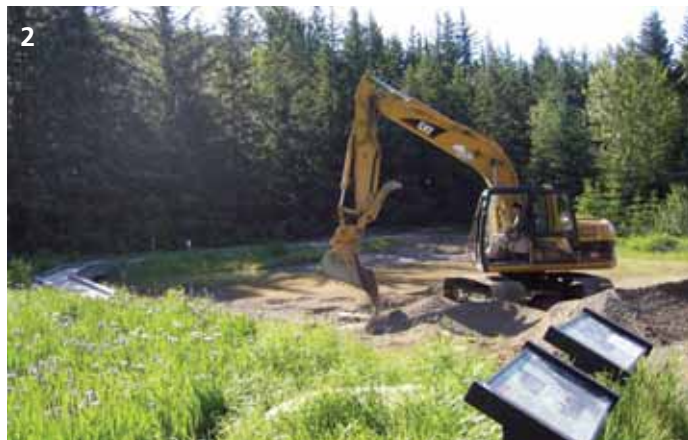
In summer 2004 the park hired local contractors to reconfigure the slough. Construction activities occurred over a two-day period and required large volumes of gravel and soil. Before work began, the fish in the slough were trapped and removed from the area so they would not be affected.

In 2003 the park biologist used base funds to hire a local firm specializing in wetland and stream restoration to produce a restoration design for the site. In 2004 the park obtained approximately \$20,000 from the NPS Water Resources Division to implement the restoration plan. The reconfiguration of the channel profile occurred over a two-day period and required large volumes of gravel and soil. Water quality monitoring was done before, during, and after the construction. Aquatic macroinvertebrates were also sampled at the site. Before work began, the inlet and outlet of the slough were fenced off and all fish were trapped and removed from the area so they would not be affected by construction activities.

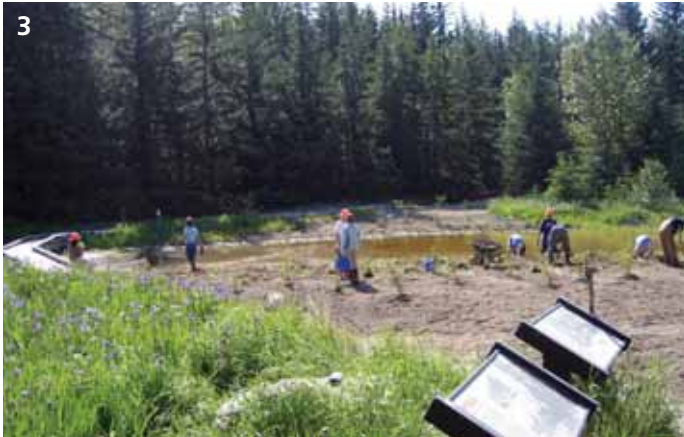
Immediately following construction activities, park crews, with the assistance of the Southeast Alaska Guidance Association, transplanted wetland and upland plants from adjacent areas into the restoration site. Very little mortality was observed for the approximately 200 native plants that were relocated to the site.

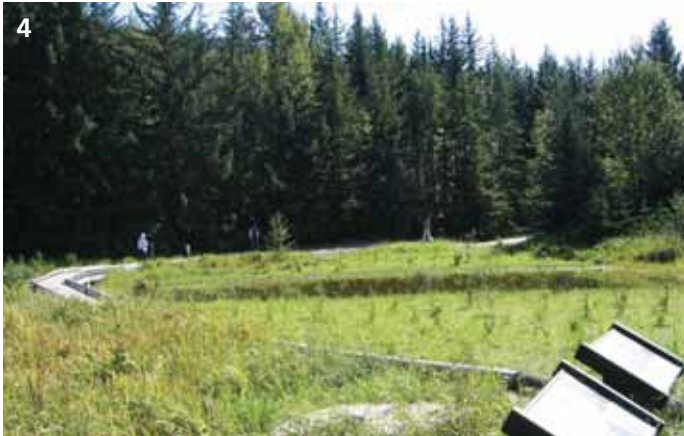
By 2005 the site had begun to recover from restoration activities. Park staff worked to ensure the long-term success of the restoration by continuing to revegetate the area, controlling nonnative plants, and meeting with local school groups to talk about wetland ecology.

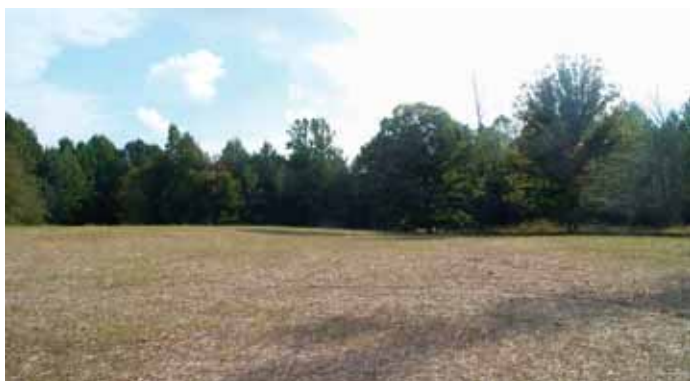
All trash, buildings, and concrete and asphalt rubble were removed and a swale was constructed to restore historical drainage. The project also included treating invasive vegetation and planting native grasses and trees. This photo shows the Bradford tract after reclamation.

Initial reclamation was completed in the summer of 2005 and included removal of more trash, concrete, asphalt, and all remaining structures; regrading the terrain; and restoring historical drainages by creating the swale with approximately 5,000 cubic yards (3,825 cu m) of compatible material obtained from a local construction site. Staff planted native grasses and 120 native trees, including red maple (*Acer rubrum*), river birch (*Nigra betula*), tulip poplar (*Liriodendron tulipifera*), sycamore (*Platanus occidentalis*), pin oak (*Quercus palustris*), and sassafras (*Sassafras albidum*).

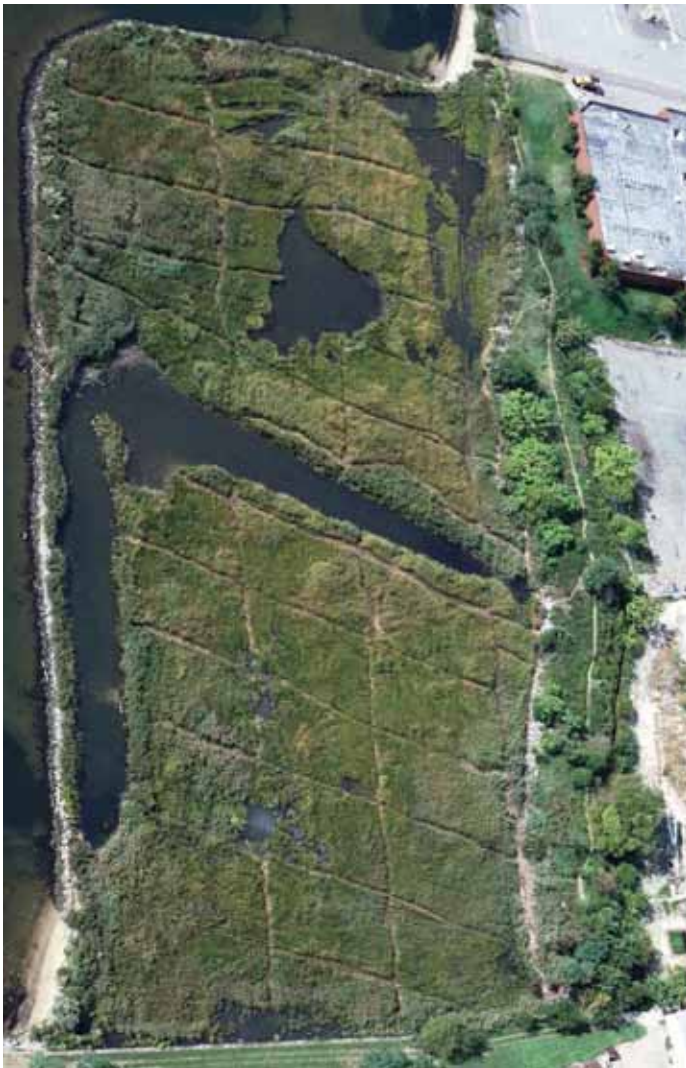
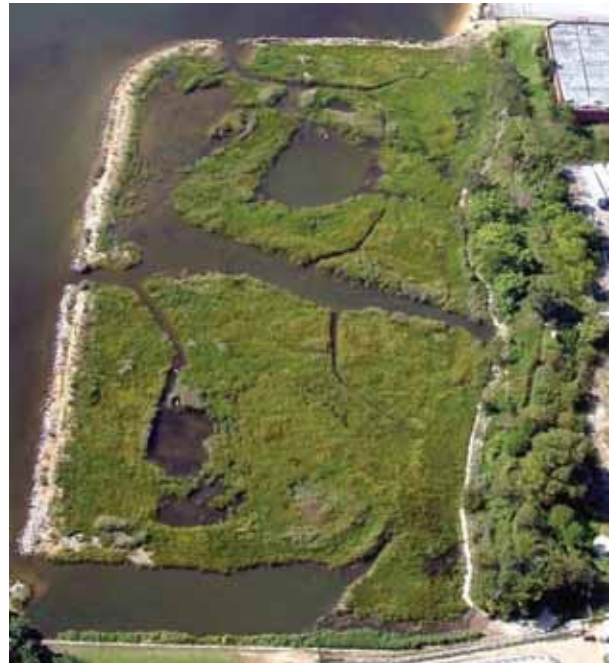
With the assistance of the National Aquarium in Baltimore and the Maryland State Port Administration, the Fort McHenry tidal wetlands were reconstructed in 2004 (shown before restoration, left) to improve hydrology and eradicate phragmites, an invasive reed, resulting in a dramatic increase in native plant and animal life (shown after restoration, right). Since 1997, park staff has worked with partners and volunteers on quarterly cleanups to remove trash and debris. Educational programs provide opportunities for schoolchildren to learn about marsh ecology, pollution, and other environmental issues.

The project involved cutting three inlets through the existing riprap and constructing a network of tidal channels in the marsh to promote regular, natural tidal flooding. The National Aquarium in Baltimore and the Maryland Port Administration cooperated in developing the design with assistance from the National Park Service. The reconstruction was needed because three small culverts, built in the 1980s, had filled with silt, largely cutting off tidal exchange and resulting in several deleterious effects to the wetland. Primary among these were invasion and colonization by common reed, *Phragmites australis*. The clogged culverts also prevented the juveniles of migratory fish species, including striped bass, perch, and herring, from using the site as nursery habitat. After reconstruction, the aquarium and volunteers planted more than 50,000 native plants throughout the site. More recently the state has followed up by removing the phragmites.
